Cyclone Gabrielle

Health & Safety
Learnings

August 2023

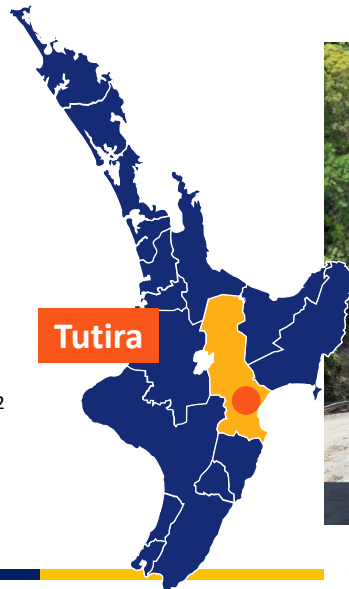
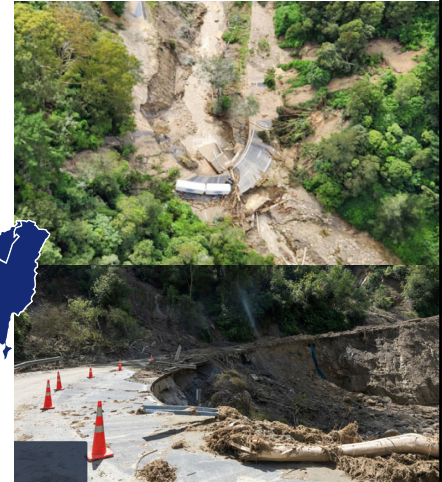
6 Line Mechanics Isolated – Tutira SH2

- Weather Warning Hawkes Bay – **Orange** rain and wind warning
- Monday 13th February normal heavy rain event (nothing significant)
- Feeder trip (Tutira area) – weather no different to normal weather event, minimal faults – team left 3pm
- Tutira – rugged terrain with 3 ways in/out – 1-way safest route SH2
- 5:00pm onwards the cyclone arrived!
- 6-line mechanics attempted to leave remote rural area – weather worsened
- First crew stuck due to a slip, picked up by the second crew, travelling together got stranded on SH2
 - Camp out in their vehicles overnight
 - 2 hourly welfare check ins with NOC
 - Confirm their next of kin aware of the situation
 - Team – wet, cold
 - Rescued truck driver

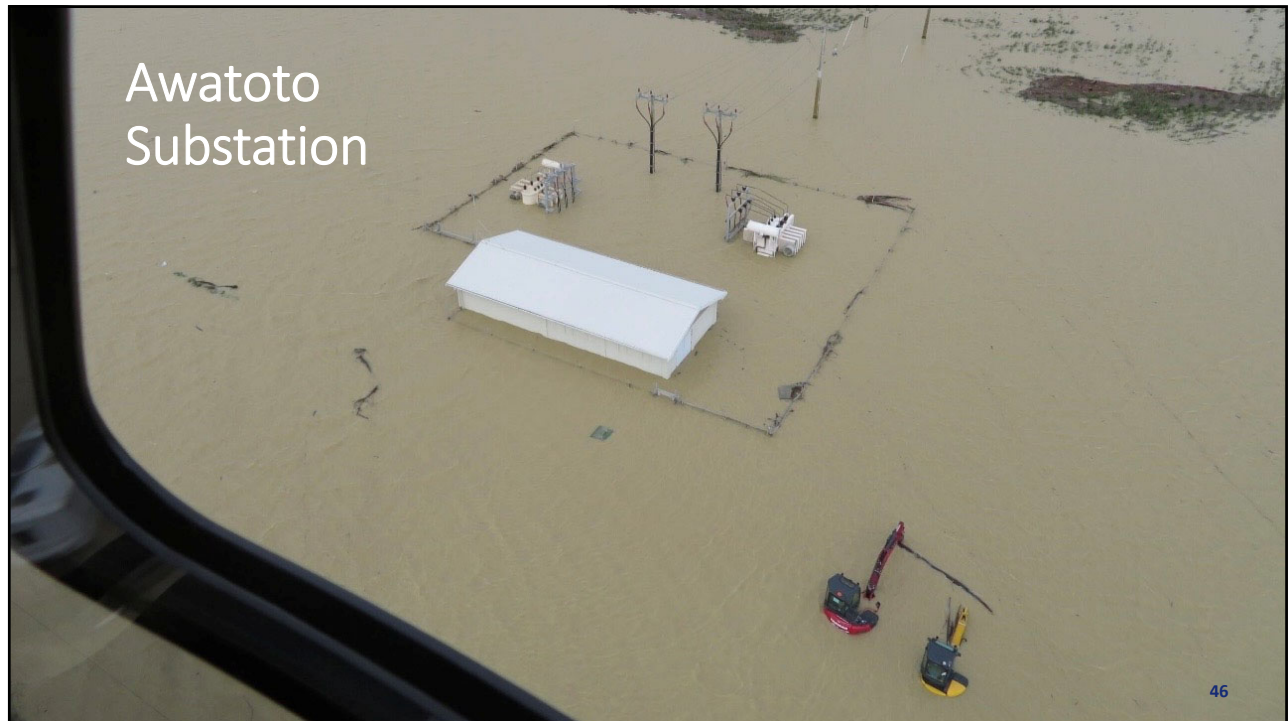
Awatoto
Substation

Napier City Council Contaminated Cordon Area – Awatoto Industrial

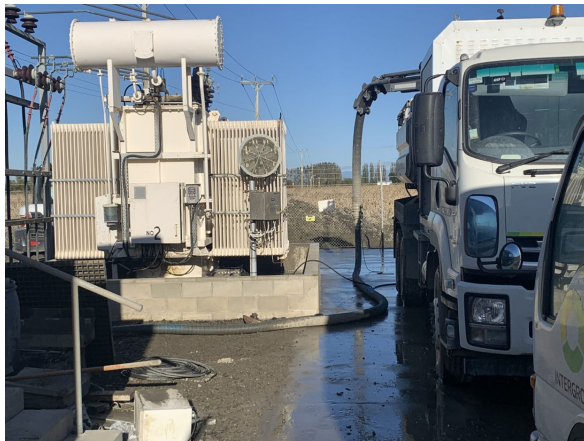
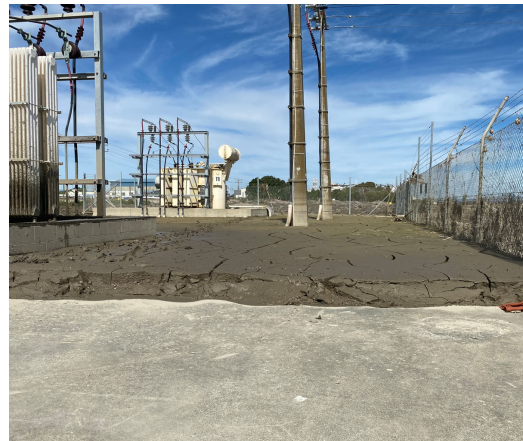
Awatoto Substation

- Before & After Cleaning Photos

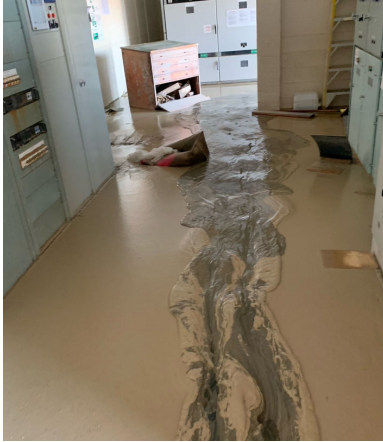
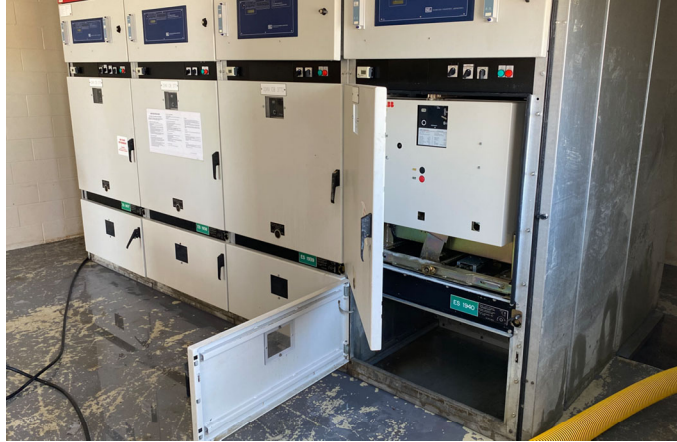
Awatoto Substation

- Before & After Cleaning Photos

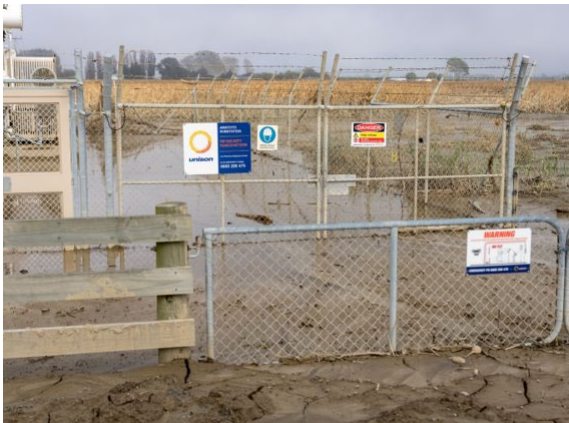
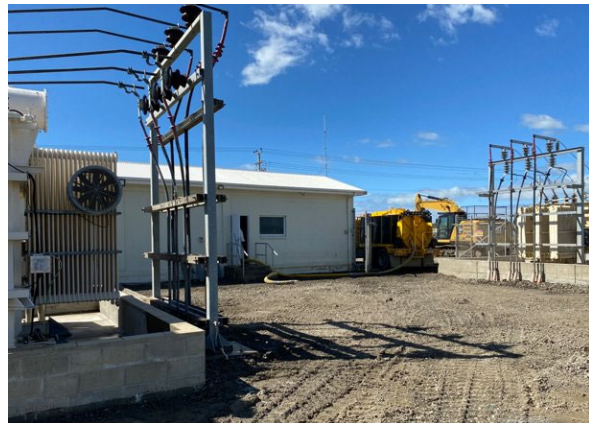
Awatoto Substation

- Before & After Cleaning Photos

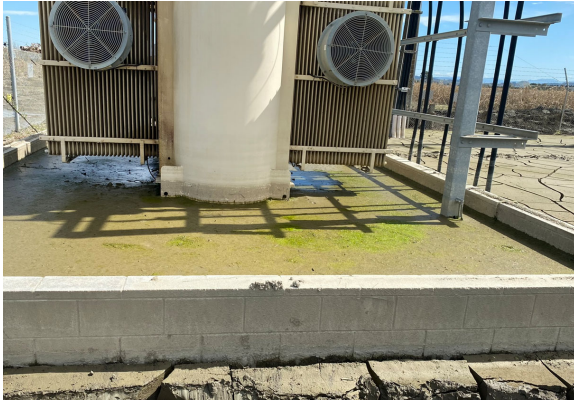
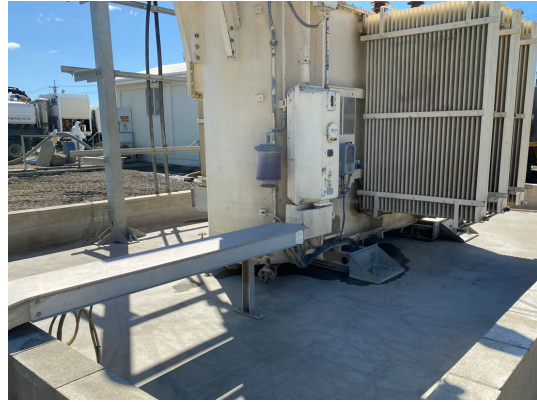
Awatoto Substation

- Before & After Cleaning Photos
