Supporting Franklin District Growth

Tuakau 110/22kV substation establishment

*Bary Babu,
Planning Engineer,
Counties Power*

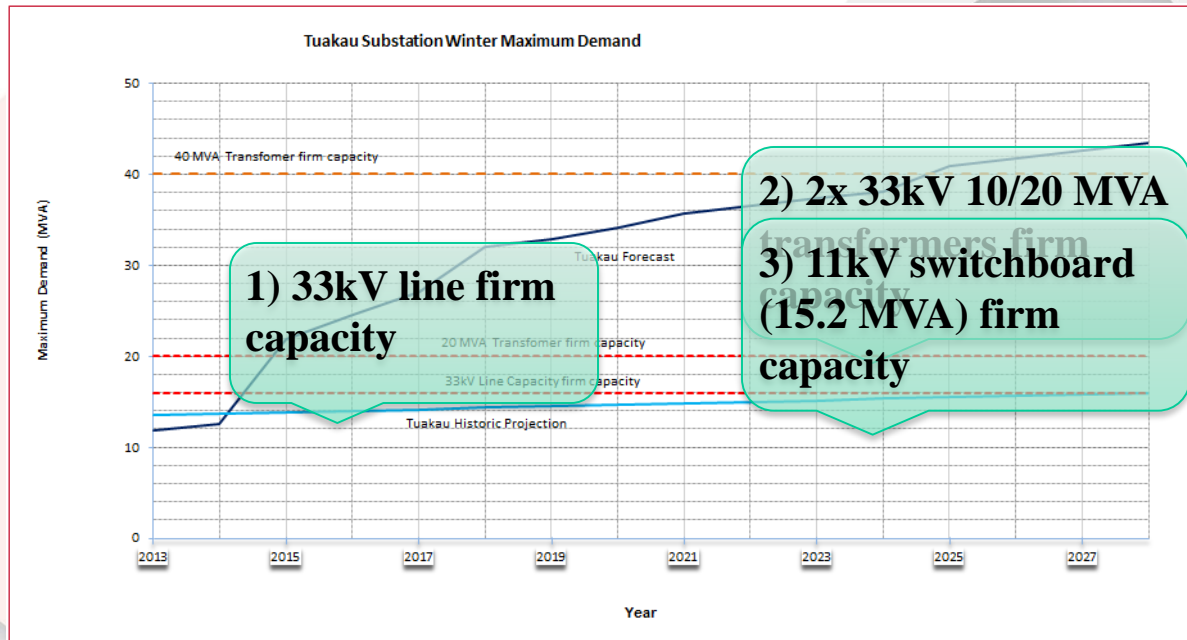
The Tuakau Substation projection highlights system constraints

Projected major load increases for the substation are:

- 2013 WaterCare Services Waikato Water Treatment Plant (WWTP) expansion (4.8MW by 2015)
- 2014 Yashili Dairy Plant at Pokeno (3.7MW)
- 2015 Pokeno Development, 0.2MW per year from 2015

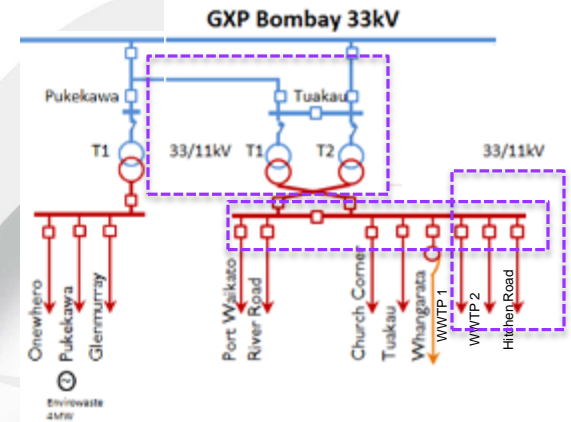
Option A: 33kV Substranmission

Three 33kV lines from Bombay
(requiring the total rebuilding of two 33kV lines, additional transformer and new switchgear)

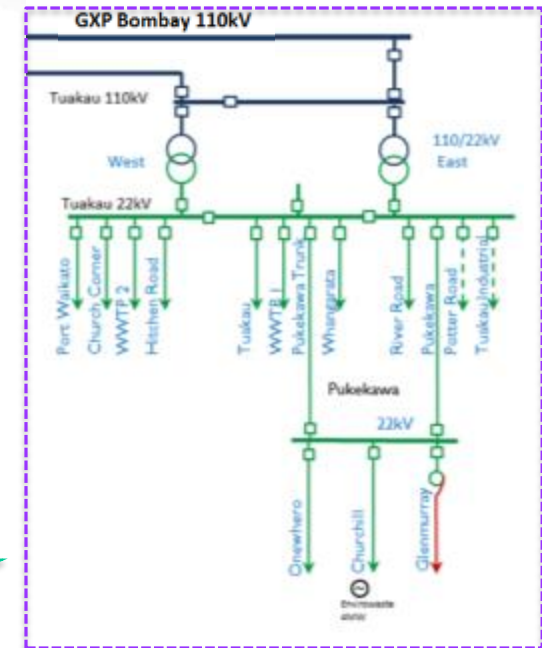
Option B: 110kV Substranmission

Alternative B1: Two 110kV lines from Bombay

Alternatives B2: One 110kV line from Bombay and one from Pukekohe

(Both alternatives only requiring one line to be rebuilt, installing 2x 20/40 MVA transformers and new switchgear)

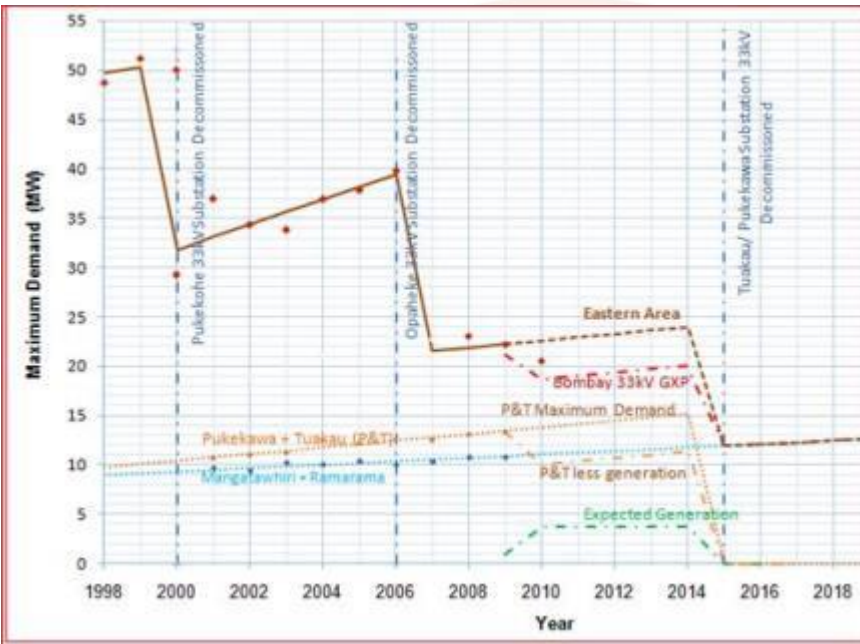
■ Reduction of load on the 33kV Bombay GXP

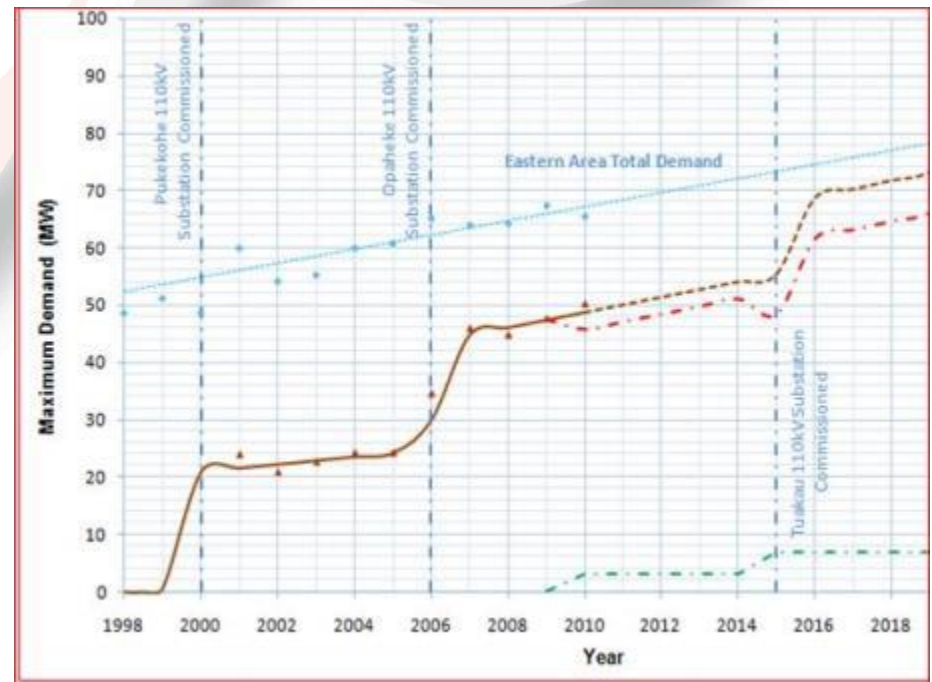
■ Increase of load on the 110kV Bombay GXP

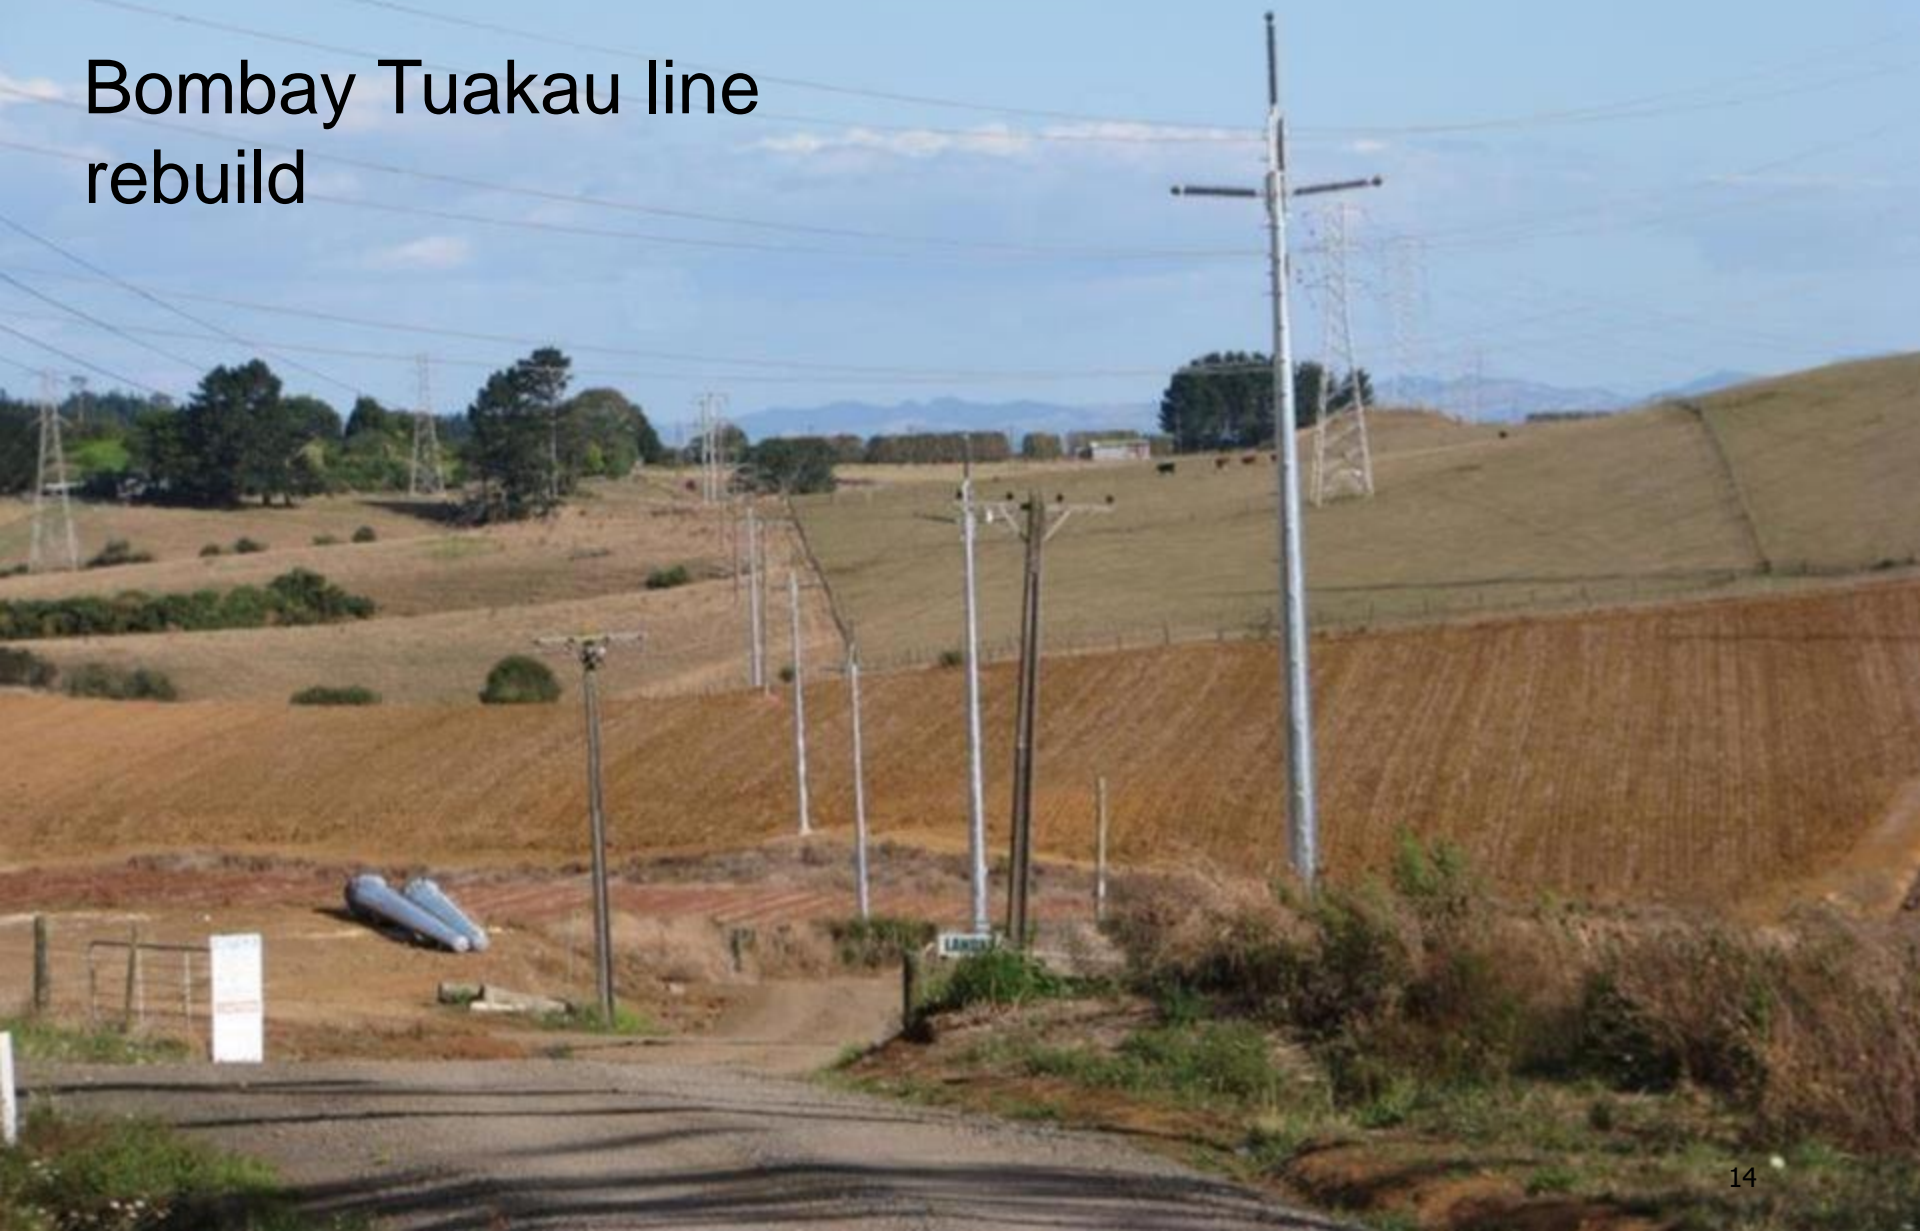
Bombay Tuakau line
rebuild

- Build new 110kV Tuakau Substation
- Build new 110kV Pukekohe–Tuakau Line
- New 110kV line bay and 110kV bus structure at Pukekohe
- Rebuild 110kV Bombay-Tuakau Line, 1929 wood pole line
- Relocate the Pukekohe 20/40MVA transformers to be installed at Tuakau
- Install two new 30/60MVA transformers at Pukekohe
- 22kV conversion of Tuakau feeders & Pukekawa feeders

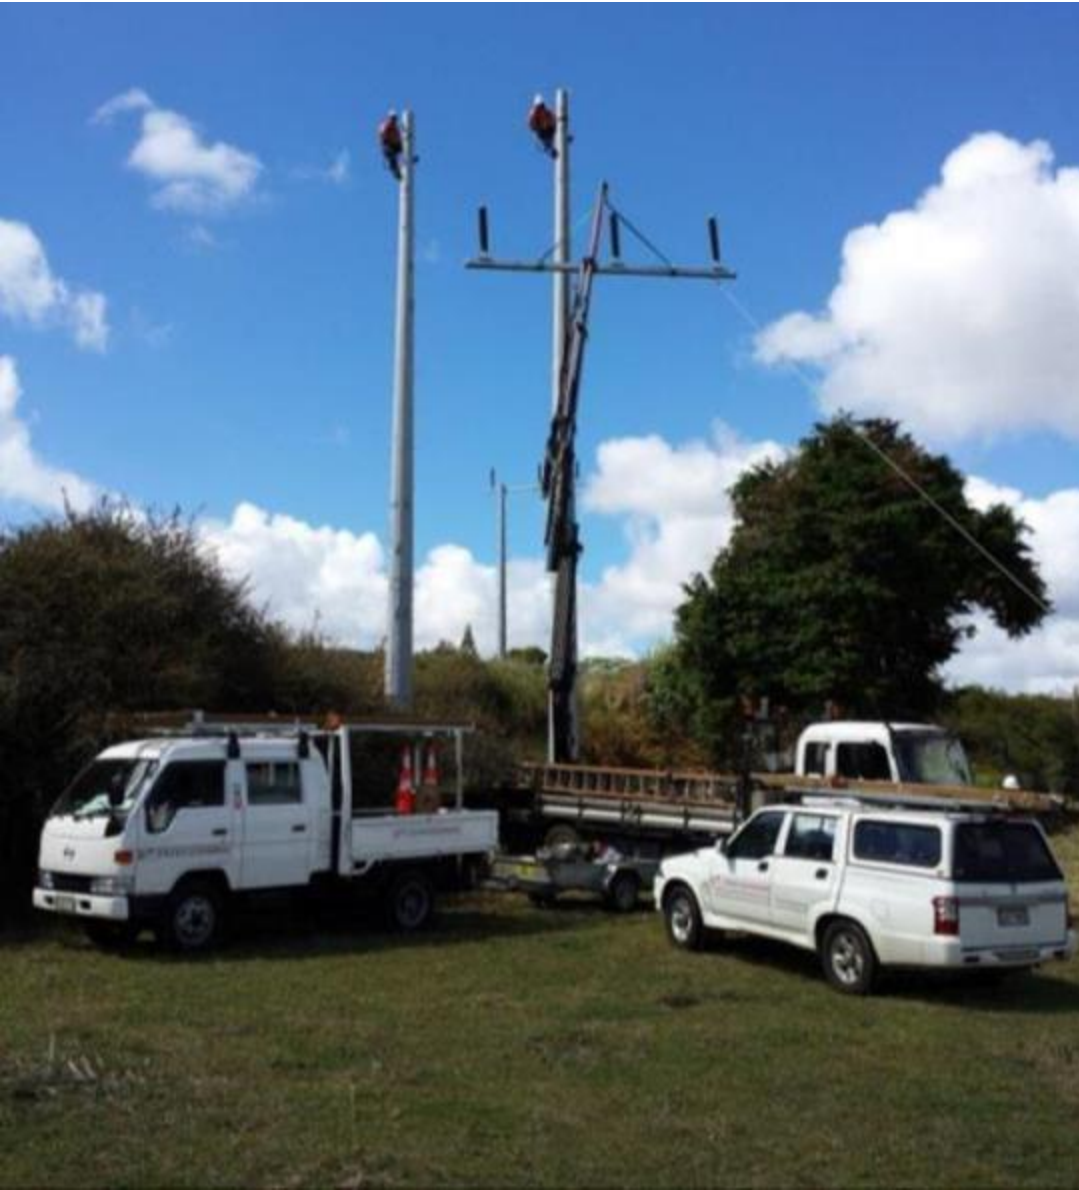
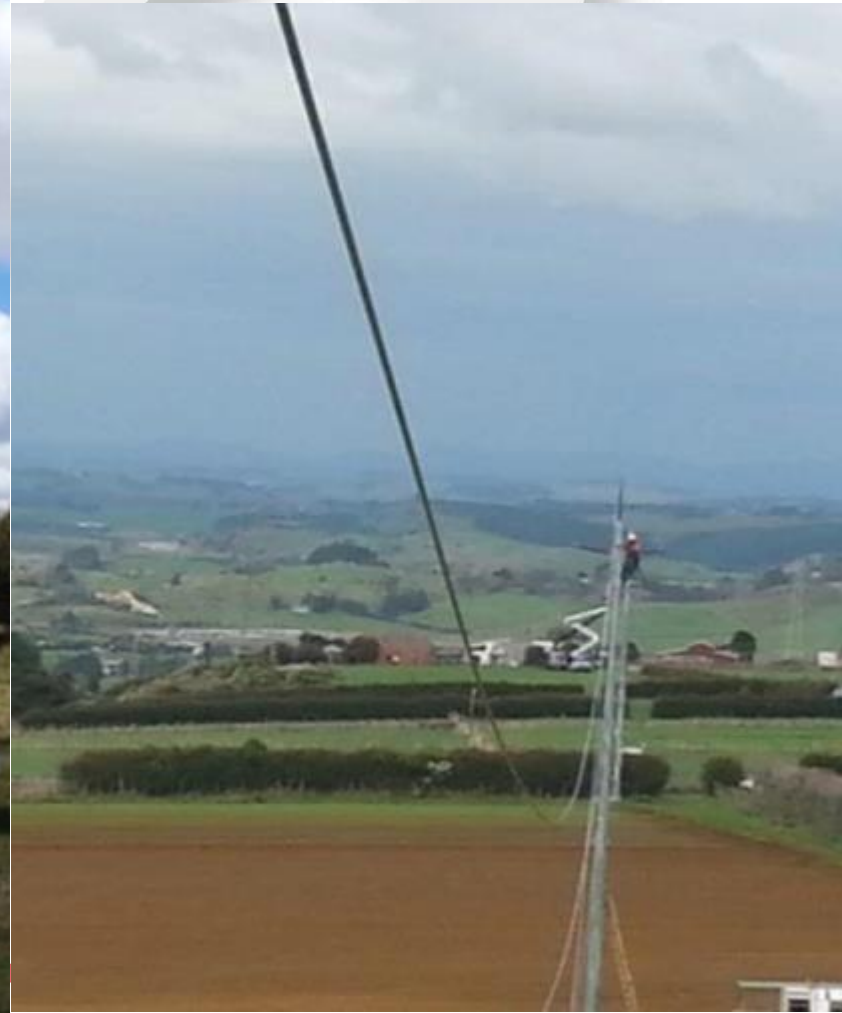
Pukekohe-Tuakau 110kV line

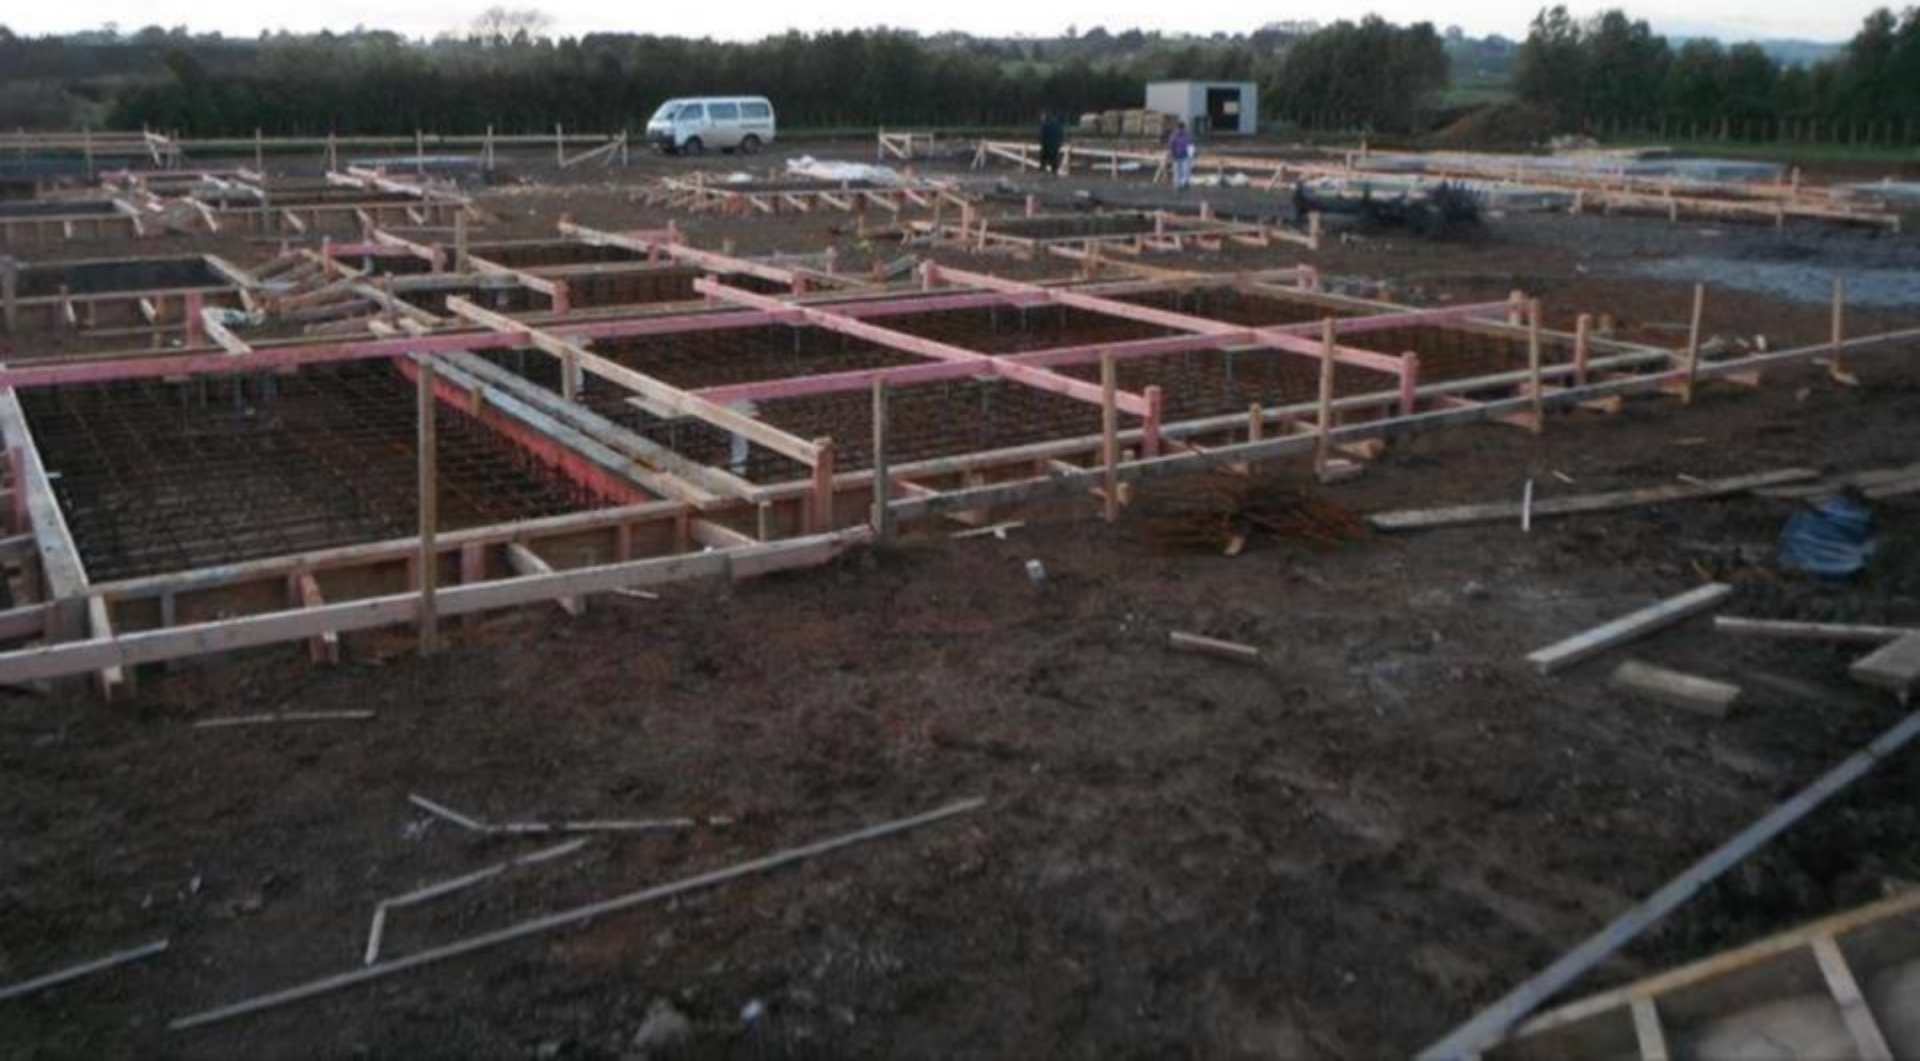
Foundations for 110kV switchyard

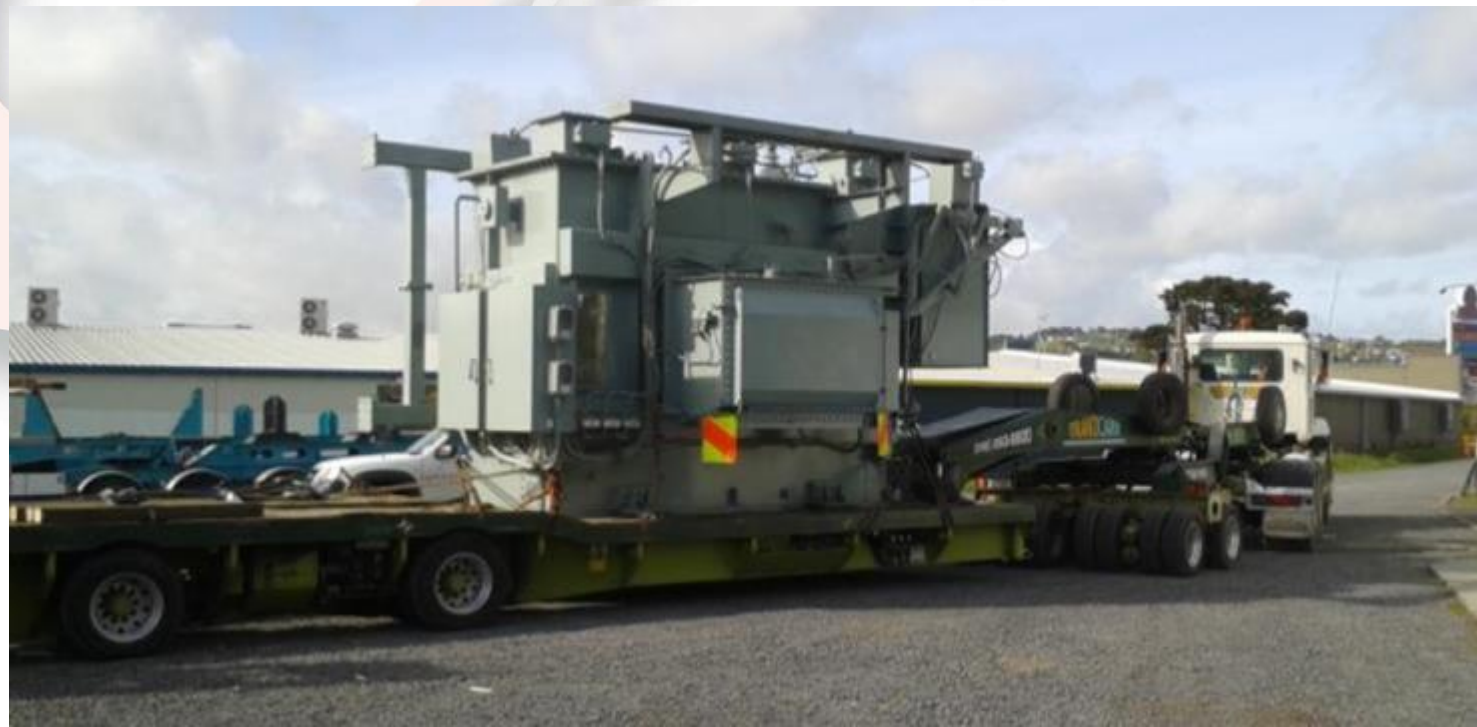
Relocate 20/40 MVA transformers from Pukekohe Substation to Tuakau Substation

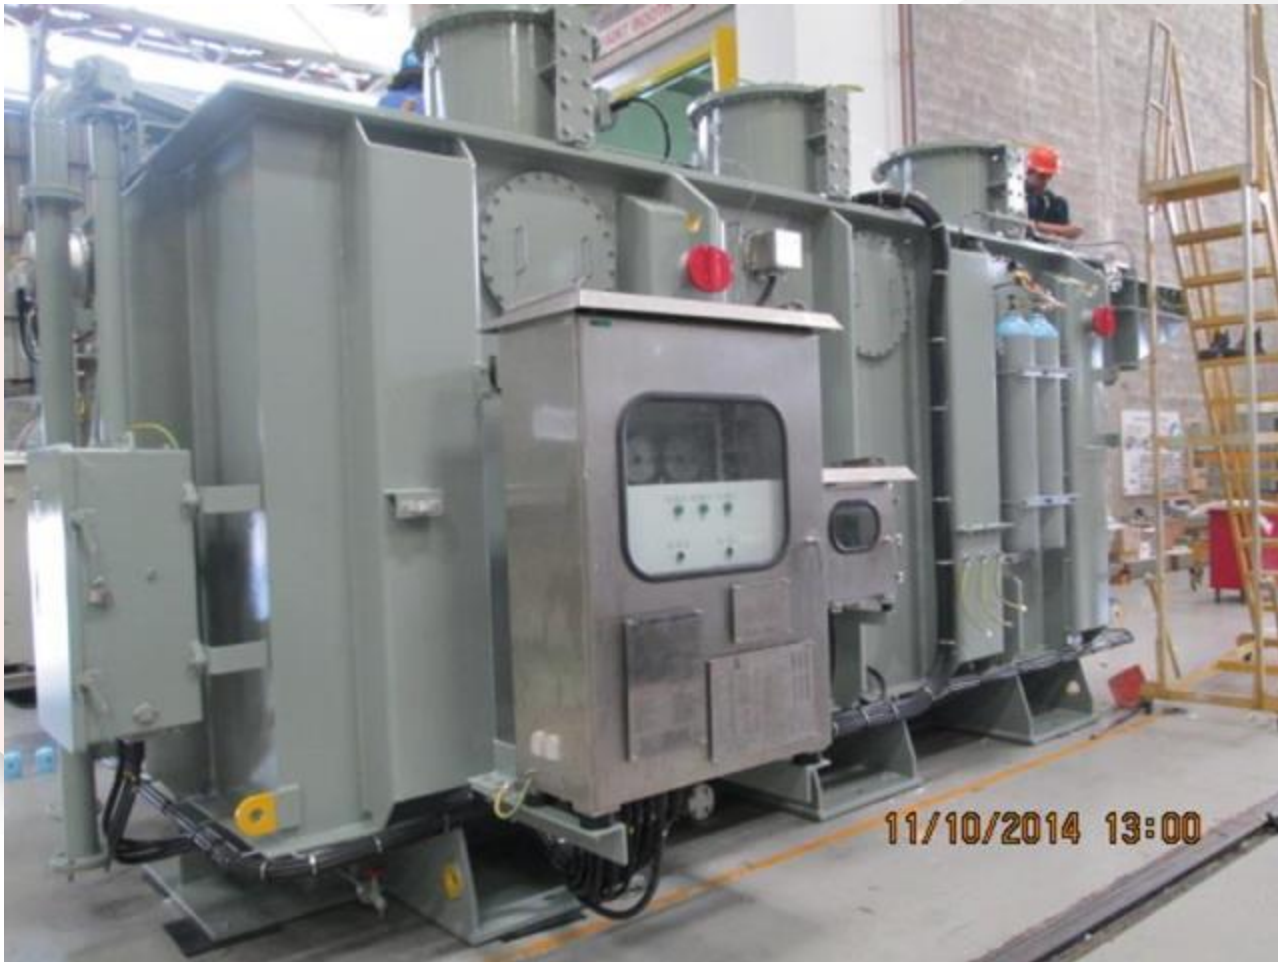
Most expensive equipment – 2x 30/60 MVA
110/22kV Transformers from PT CG Power
systems, Indonesia

Witnessing Factory Acceptance Tests (FAT) at
PT CG Transformer Factory

- Factory located in Indonesia
 - September 2014
- Independent Transformer inspector engaged for FAT
- Transformers were tested according to IEC 60076

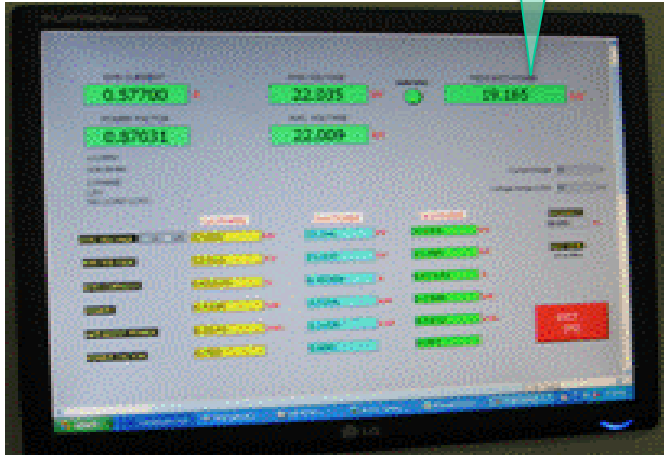
- No Load Losses and Load Losses – Losses measured have to be within the guaranteed value
- Guaranteed no load loss value was 21kW

19.16kW

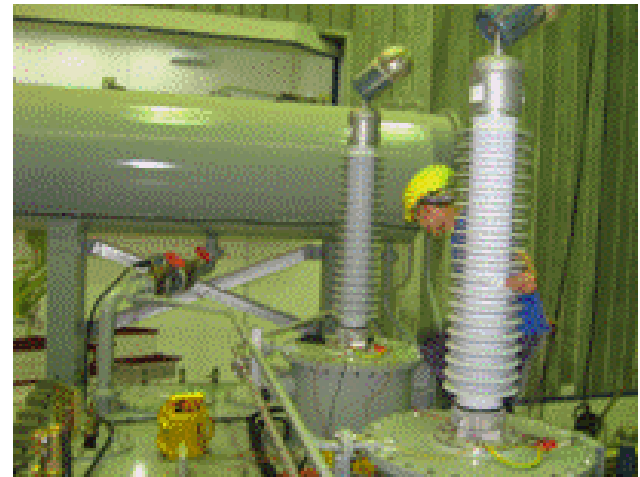
- Partial discharge testing
- Looking for breakdown in insulation or high electrical stress points that over time degrade metal resulting in failures
- Very common to find Partial discharge in the Bushings

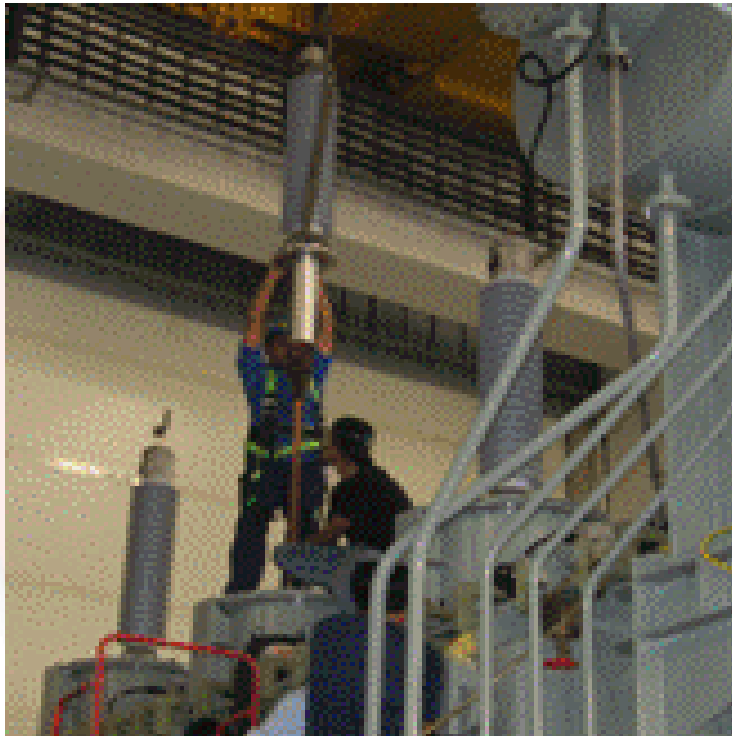
Partial Discharge detected

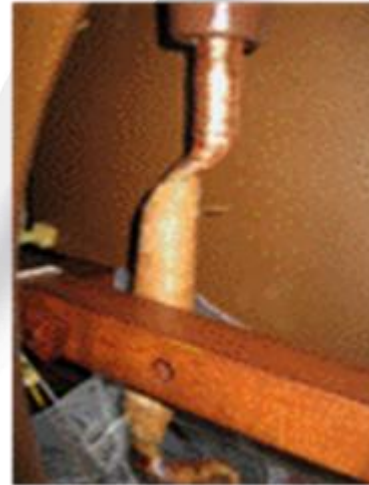
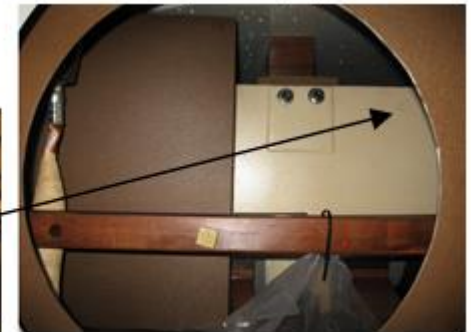
Enlarged view of lead wrapped with insulating paper

Smooth surfaced caps for nuts

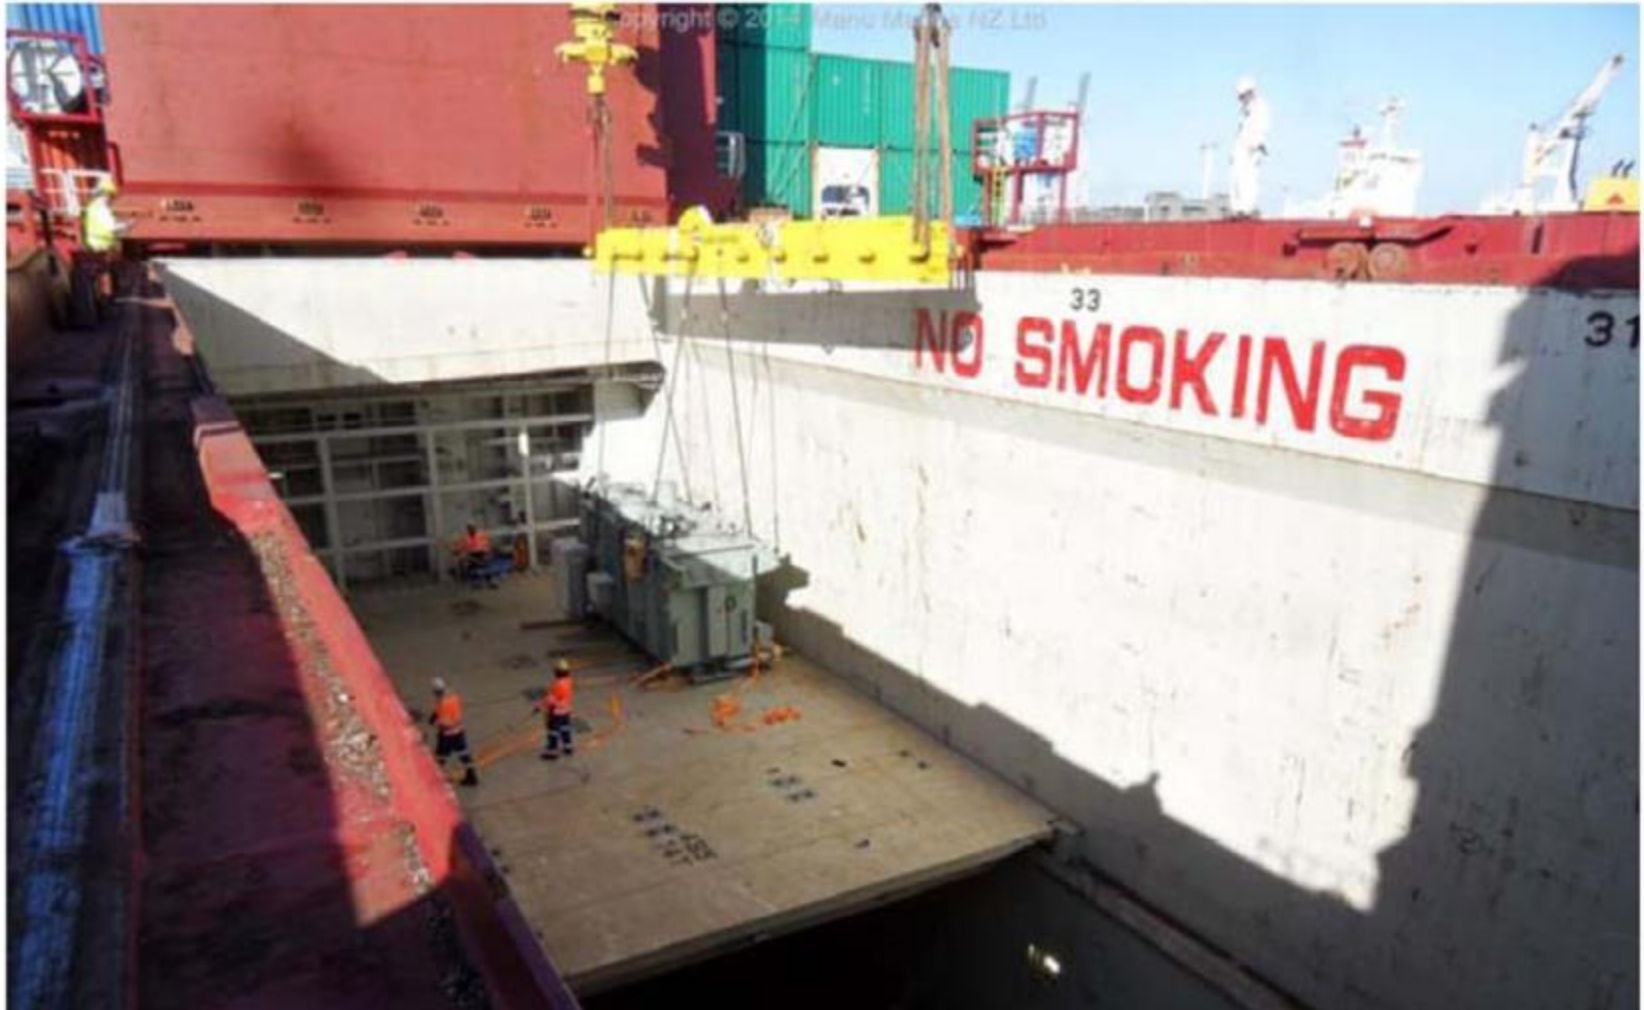
Unit one arrived from Cileungsi, Indonesia to Jellico Wharf, NZ on the “Shansi”. Inspected for damage
