**POWERCO**

A Statistical Survey of Powerco Network Prestressed Pole Strength

Crossline Test and Downline Test

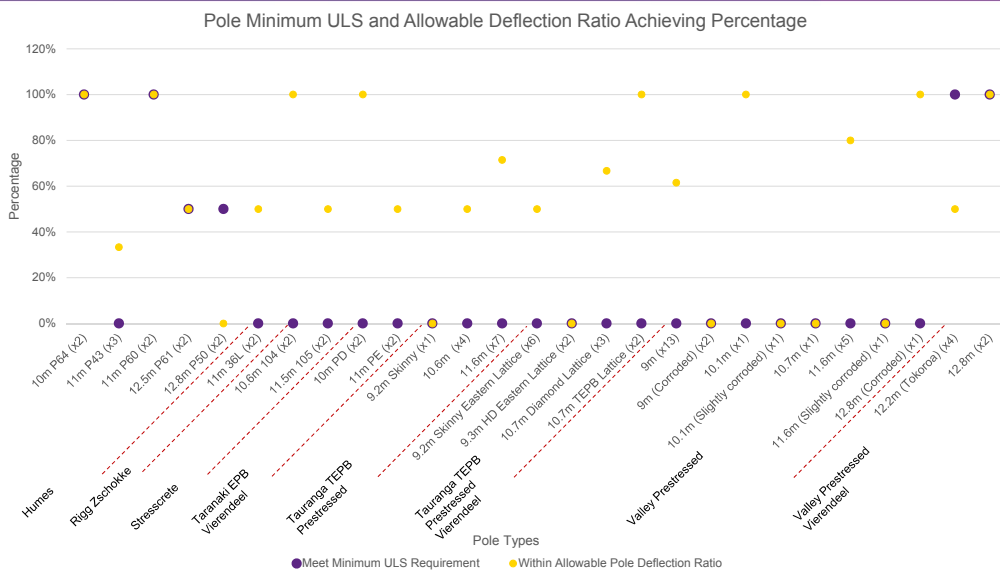
Allowable Pole Deflection Ratio and Minimum ULS 393S082A Powerco New Poles Standard

- Allowable Pole Deflection Ratio:
 - No less than 10%
 - No more than 15%
 - When at the poles Breaking Load (BL) limit

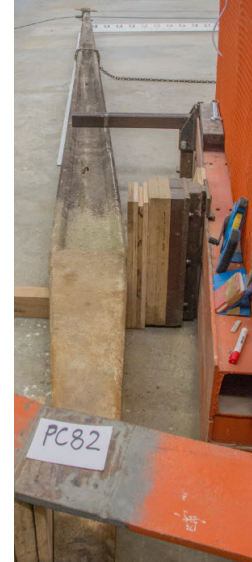
Valley Poles (9, 10.1, 10.6, 11.6, 12.8)

- The Valley prestressed poles have two corrosion issues, which can be present without a visual indicator.
 1. The pole contained a flat concrete block, which is too smooth to bond with the cement mixture. This allows moisture to seep in and cause corrosion of the steel.
 2. Insufficient concrete cover has allowed internal corrosion of the steel.
- The Valley 9 pole has up to 5 variations, but they used the same spreader block and the same corrosion problems still exist.
