Overview

- RPAS has been used to inspect vulnerable sites post weather events and to monitor identified erosion sites.
- Two sites covered in this presentation
- Docertys Creek (Franz Josef) flash flood
- Crooked River (Lake Brunner) erosion

Dochertys Creek Access following South Island Flooding

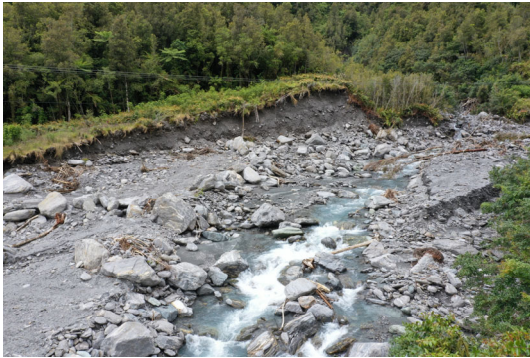
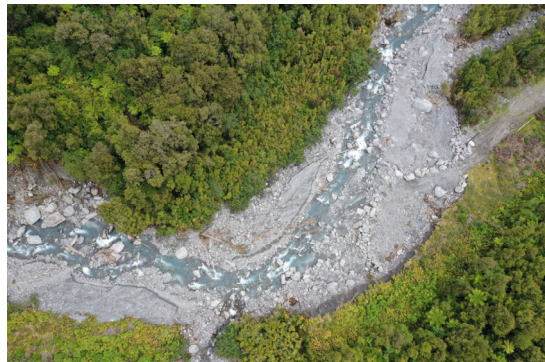
RPAS Inspection

- Following a large weather event on 8th December 2019 a flash flood washed out three structures in the 33kV South Westland Line at Dochertys Creek.
- Temporary repairs were made with what was available south of Mount Hercules due to slips, these closed the road until mid January 2020. These slips also destroyed two structures on Mount Hercules.

- Able to access site January 2020
- Line route flown
- Survey carried out and new pole positions pegged
- Design prepared

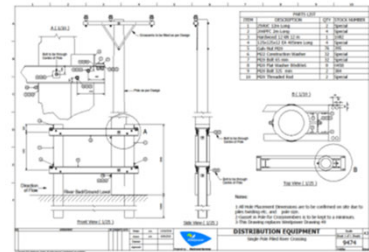
Design

- Line route limited to existing corridor as in a National Park
- Alternative routes more prone to slips
- 6 Structures installed on Piles

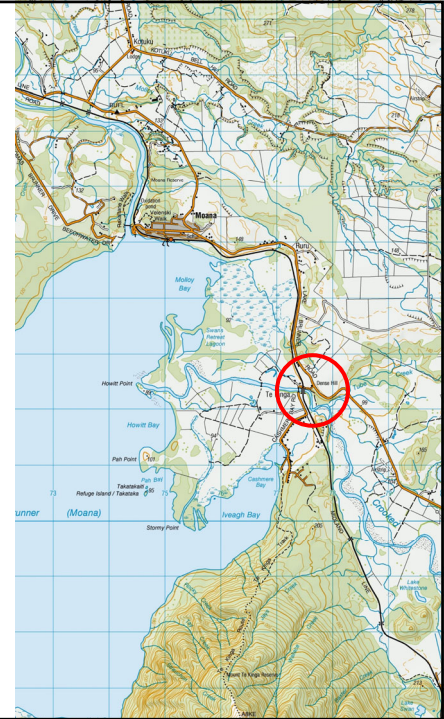
Crooked River

- The river changed course towards where an 11kV line feeding Te Kinga, a small village mainly comprised of holiday homes at Lake Brunner.

- An alternative route was looked at
- While negotiations were carried out the sight was monitored by RPAS
- A point cloud was created of the proposed line route and existing route
- The threatened pole was moved to allow for time for permanent solution to be built.

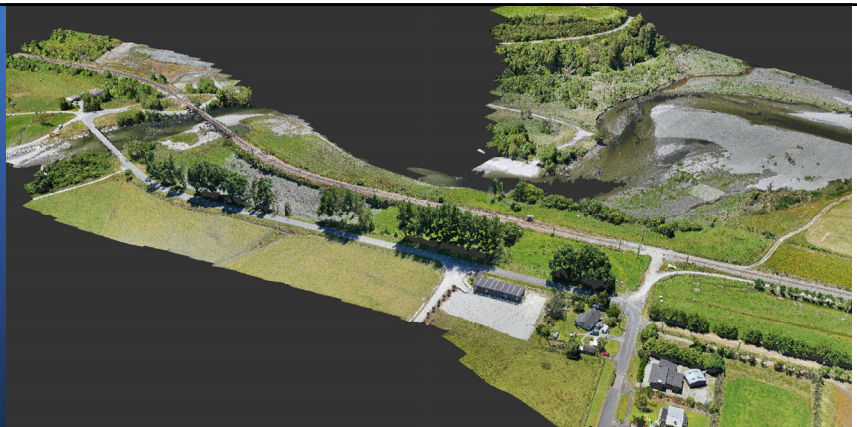
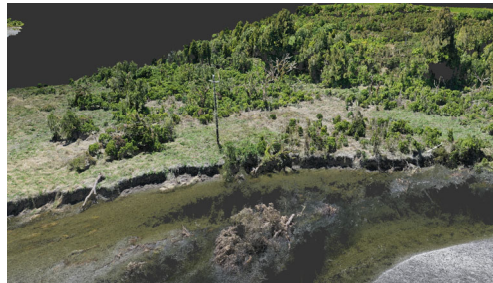
Point Cloud flown 14 January 2020

- Negotiations still ongoing
- Existing and proposed line route flown by drone
- Point cloud created
- Decision made to move threatened structure temporarily.

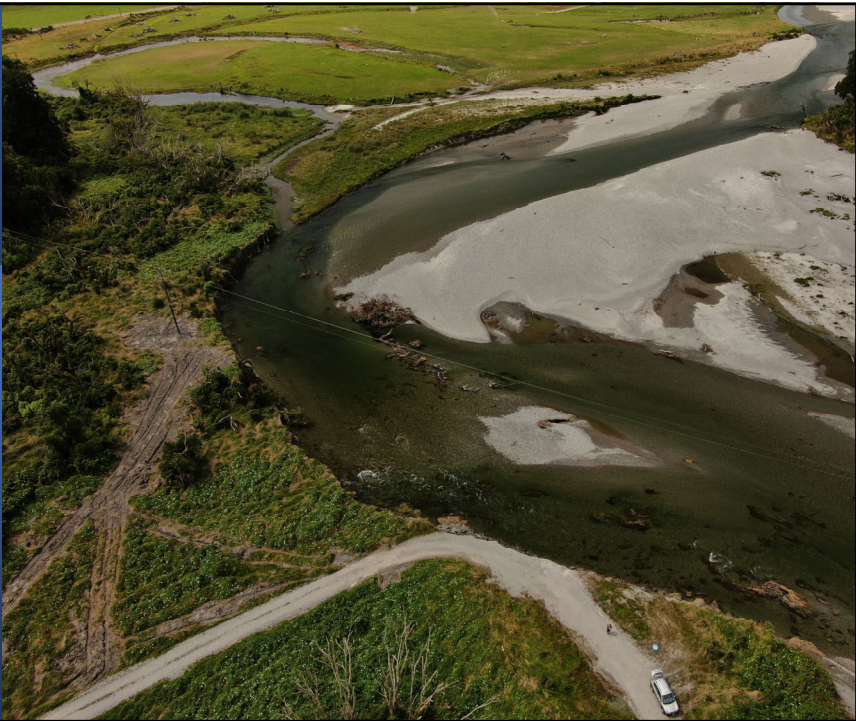
15 February 2020

Pole has been moved in January to allow time for shutdown to run new conductor
