Power Quality

John He – Graduate Electrical Engineer (Powerco Ltd)

Kapuni Solar Plant PQ Monitoring Project

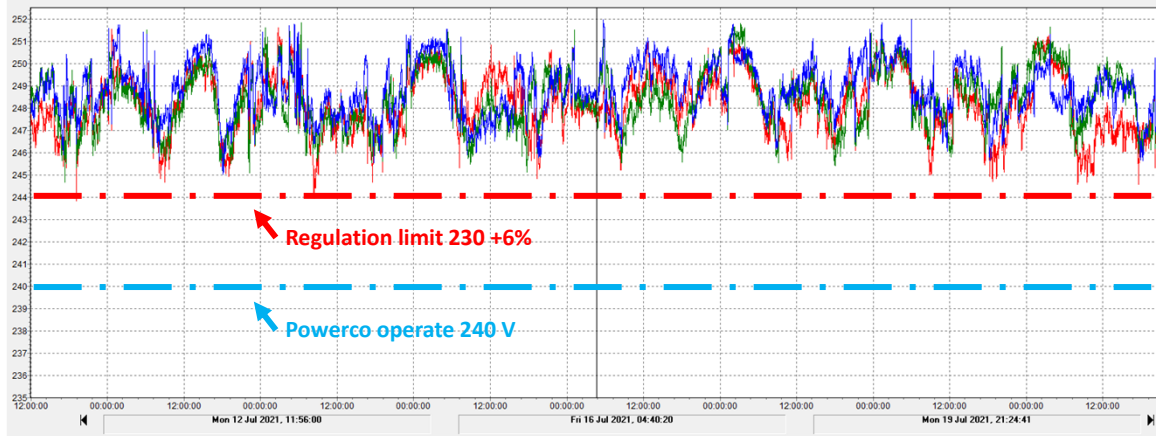
1.1 LV Overvoltage – Waveform

- 1) Apply Line drop compensation at the voltage regulator
- 2) Perform tap change (tap up) on (or all) concerning dist. transformer
- 3) Check Volt-var, volt-watt setting on solar inverter is active

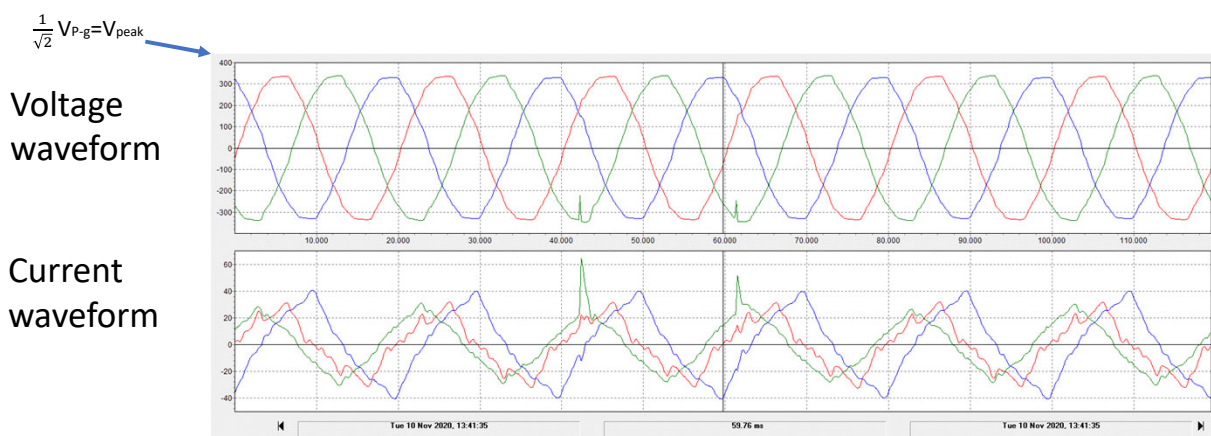
2.1 Harmonics – Waveform

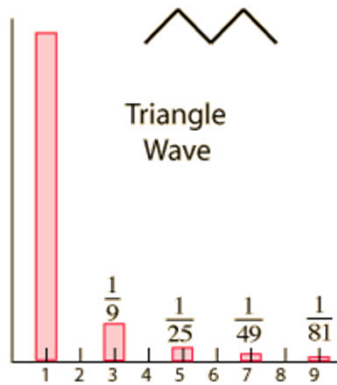
2.2 Harmonics – Cause

- Z_h (system impedance) = $Z_1 + Z_2 + Z_3 + Z_n$
- V_d (voltage distortion) = $V_1 + V_2 + V_3 + V_n$
- I_d (current distortion) = $I_1 + I_2 + I_3 + I_n$

$$V_d = I_d Z_h$$

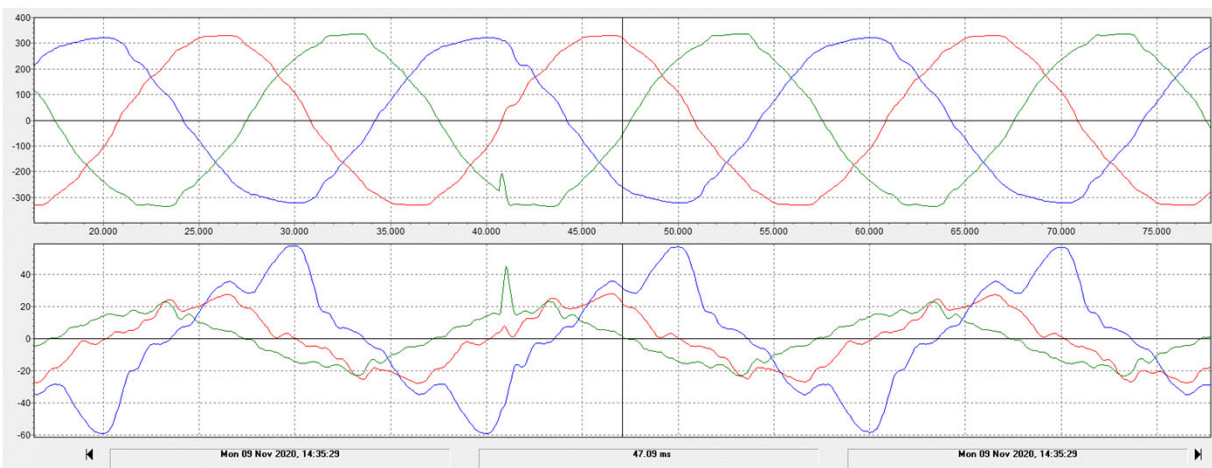
3.1 Light Flicker – Waveform

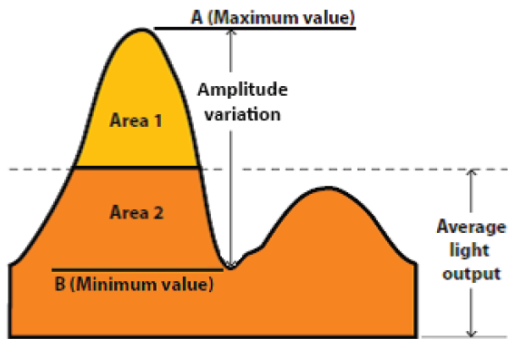
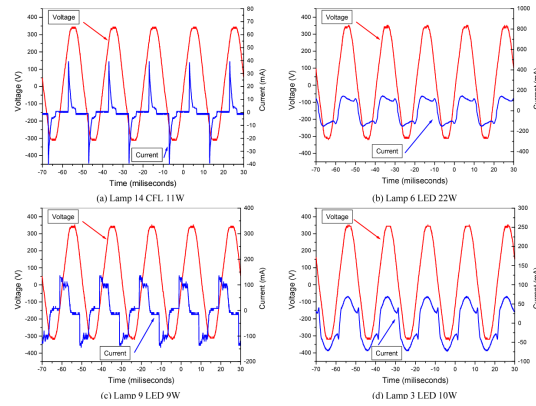
3.2 Light Flicker – Cause

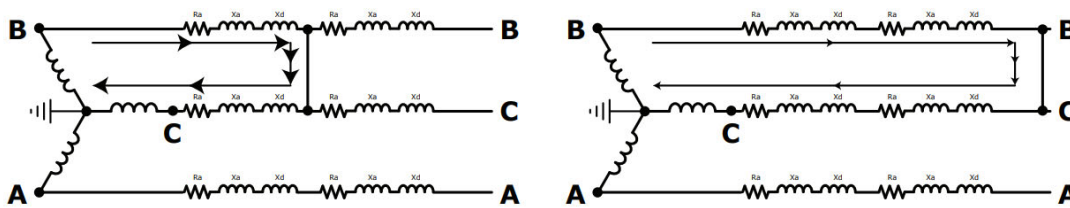
4.1 – Quick Intro to 2-Phase Faults

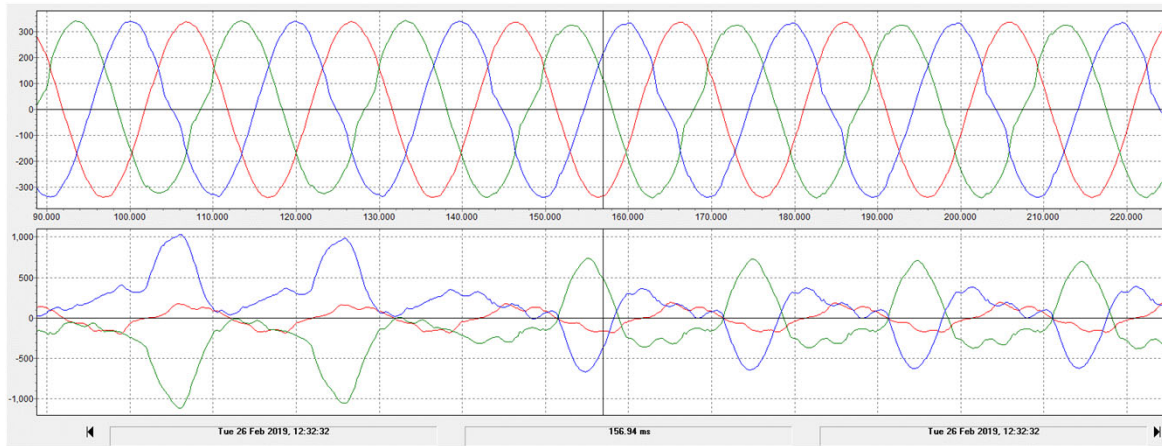
4.2 Motor Shorting - Waveform

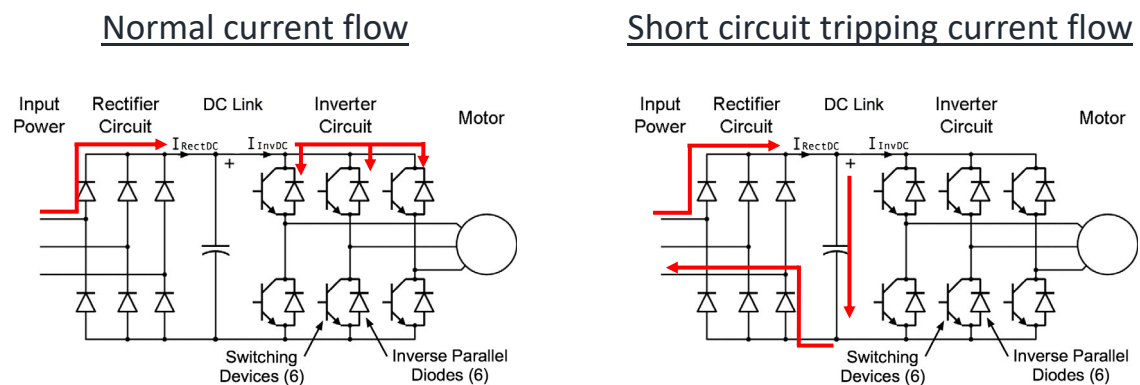
4.3 Motor Shorting - Cause

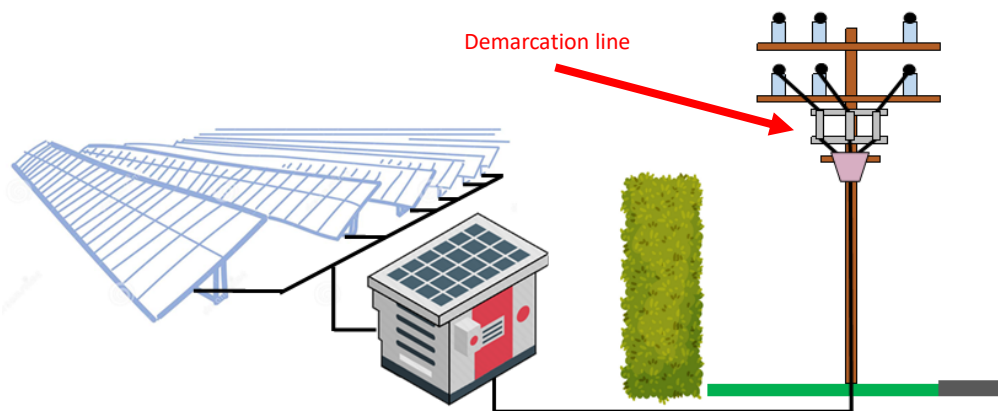
5.1 Present Solar Plant Connection to Network

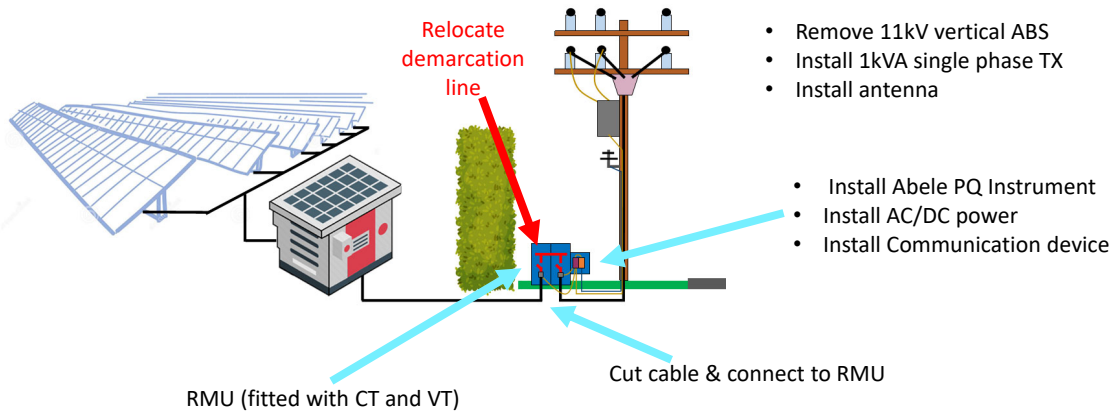
5.2 Proposed Network Change
