Conductor & Pole Condition Guide

EEA.CO.NZ

Guide Contents

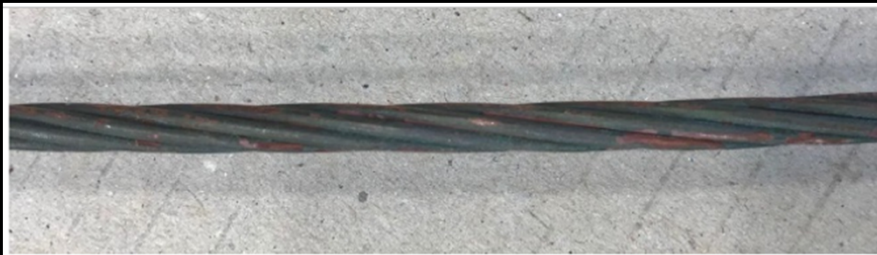
Type: Copper
Size: 7/064
Failure mode: Corrosion – Flaking Patina
Grade D3
Assessment Notes
 Conductor showing patina with flaking potentially reducing the conductor cross section.

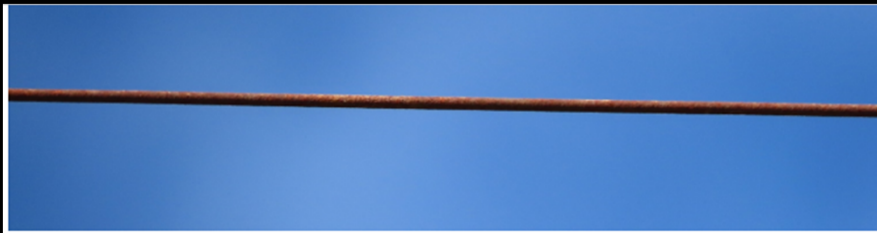
Type: Steel
Size: No.8
Failure mode: Corrosion
Grade D3
Assessment Notes
 Steel conductor showing near complete loss of protective coating and limited evidence of surface pitting.

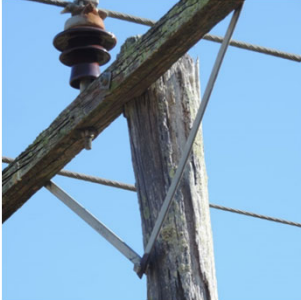
Decay: Sapwood
Grade: D3
Assessment Notes
 Apparent decay in the pole head coupled with sapwood delamination. The sapwood delamination does not appear to seriously compromise the connection of the cross-arm king bolt; however, the arm brace coach screw might be compromised. Suggest pole top photograph to confirm extent of any pole top decay if possible and replacement of the coach screw with a bolt.

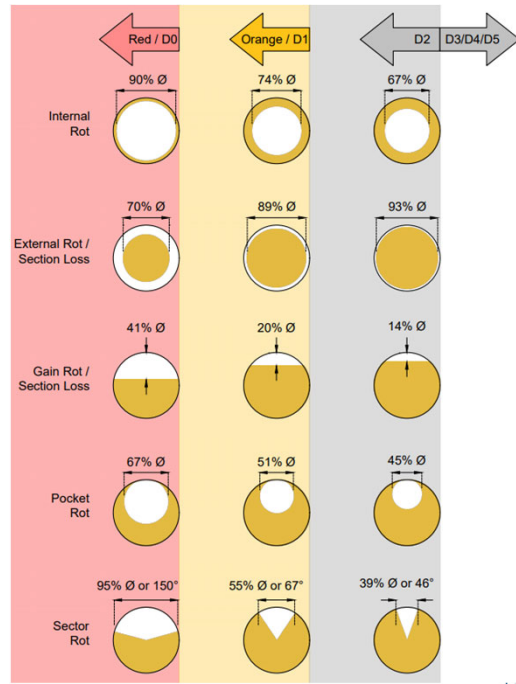
Pole guide - Normal vs Design Loads

Design loads	Loads calculated in accordance with AS/NZS7000:2016 for a design working life of 5 years. Selection of the 5-year working was selected because assets with D2 ratings should typically be remedied within 5 years of being identified, and all D1 rated poles are required to be rectified within one year.
Normal loads	Loads associated with the construction and maintenance load case defined in AS/NZS7000:2016. This includes an applied wind loading of 100Pa and loads associated with ladder climbing loads.
